# 1200 TANKS

One plan provides different coatings solutions for oil company's tanks

1,200 petroleum product tanks at various Marathon Ashland terminals

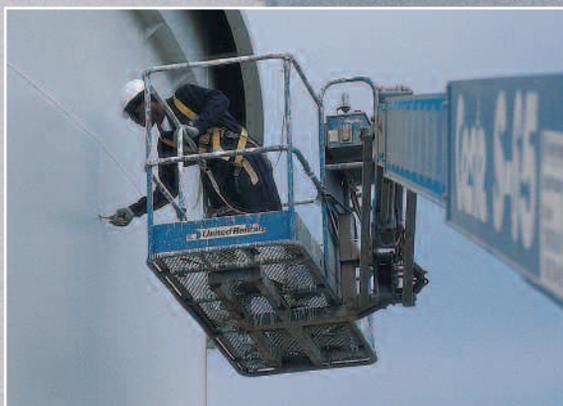
Painters took on the first of 1,200 petroleum product tanks at Marathon Ashland terminals last summer

Now underway, projects include full removal and repaints on many of the tanks, which range from 20,000 to 30,000 square feet in surface area. For these jobs, the tanks are shot- or grit-blasted to a 2.0 to 3.5-mil anchor profile, then coated with a three-coat Sherwin-Williams epoxy system. First is a

prime coat of Epolon II Primer, followed by an intermediate coat of Macropoxy HS, and topped with a finish coat of Tile Clad High Solids, each at 3.0 to 4.0 mils dft for a total film of 9.0 to 12.0 mils dft.
