BATTLING BACK

The USS Yorktown targets corrosion in coatings overhaul

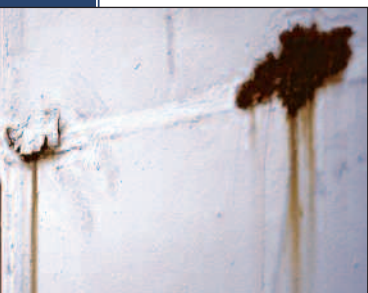
Above (top), water collected in a variety of areas aboard the Yorktown, leading to corrosion. Rust streaking was also a common occurrence on vertical surfaces.

Greene’s survey paid particular attention to how the ship shed rainwater, and he found many areas in which it was contained and pooled on the steel. Such retention led to corrosion in these areas, so he came up with new solutions.

“This coating system was made for coastal conditions, not immersion, so the ponding created areas of concern,” he says. “But in some of these areas, we simply drilled a hole in the bottom of the steel so the water — and the problem — went away.

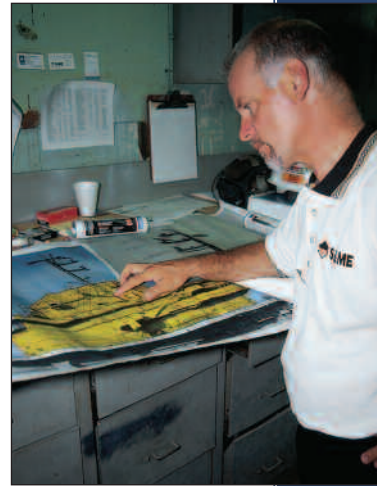
Above, Tim Greene studies a schematic showing parts of the Yorktown that are scheduled for painting.

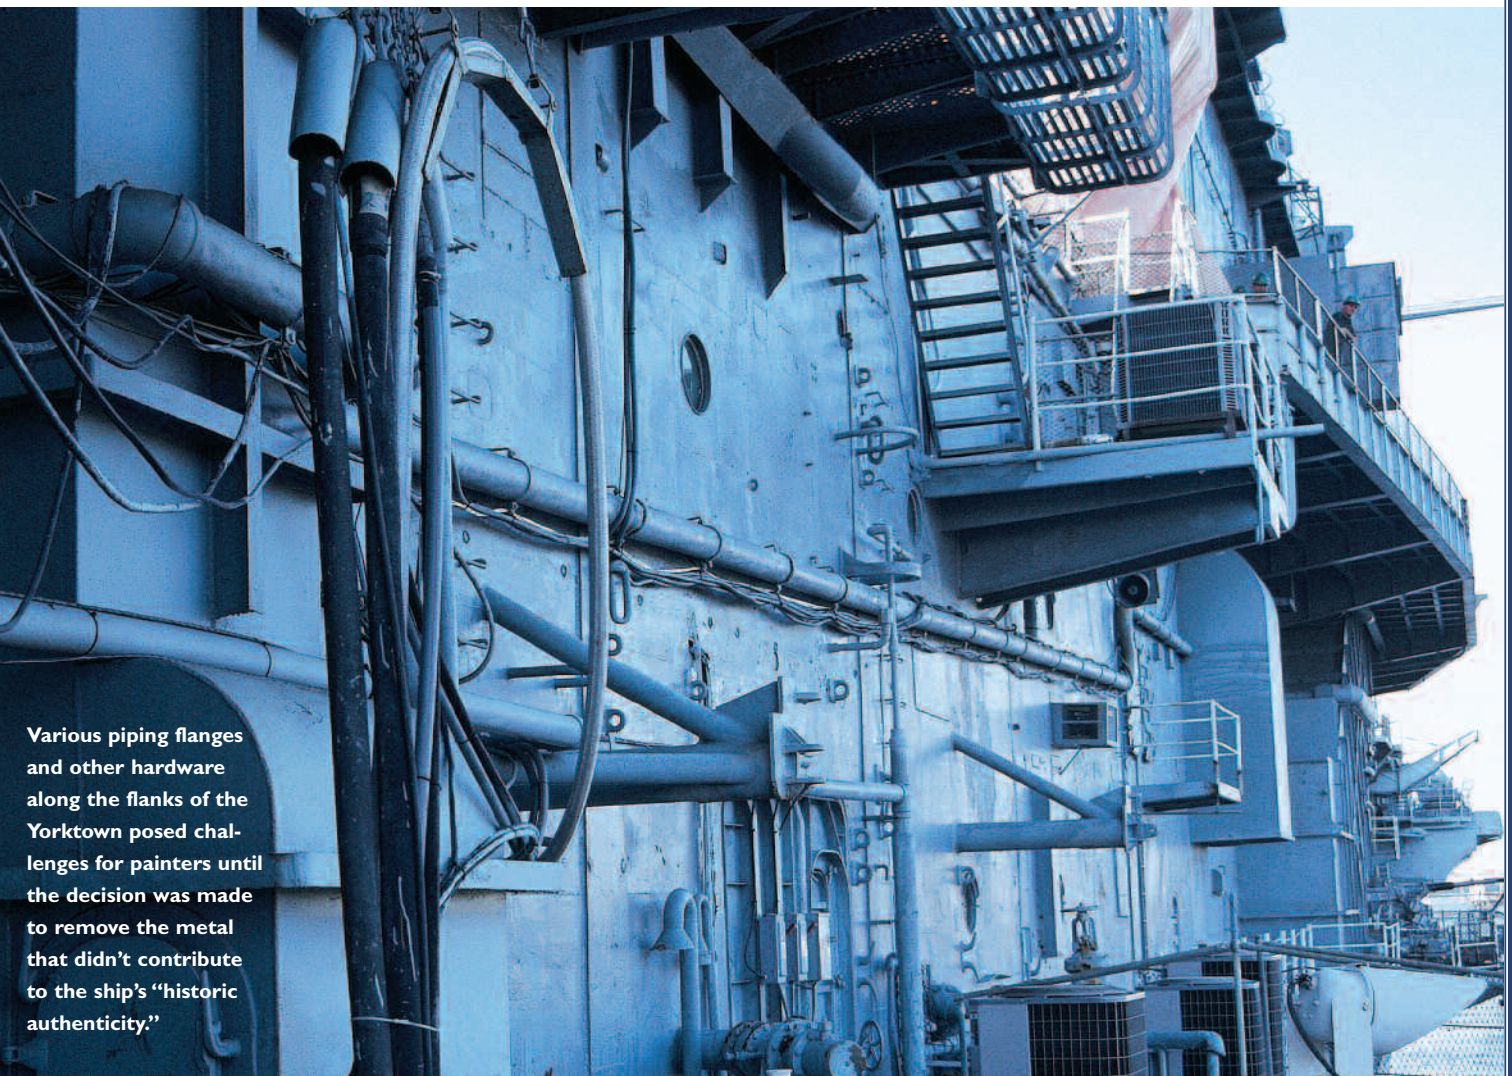
Various piping flanges and other hardware along the flanks of the Yorktown posed challenges for painters until the decision was made to remove the metal that didn’t contribute to the ship’s “historic authenticity.”

Before the five-phase, five-year application plan could begin, Howard was faced with some decisions. Various piping, hardware, flanges and other metal pieces protrude from the flanks of the Yorktown. But they’re difficult to paint and often the source of rust streaking due to the difficulty of surface prep and the greater likelihood of pinholing in those areas.

Howard determined that any such metal on the port side — the side not visible to tourists boarding the ship — that didn’t contribute to the authenticity of the ship could be removed by ship personnel prior to the contractor’s arrival, thus solving the problems associated with coating the irregular pieces. Since the starboard side was

“If it wasn’t historically meaningful on the port side, we cut it off,” says Howard. “There are some purists who might take issue with that, but again, we had to take a long-term view of what was best for the ship.”

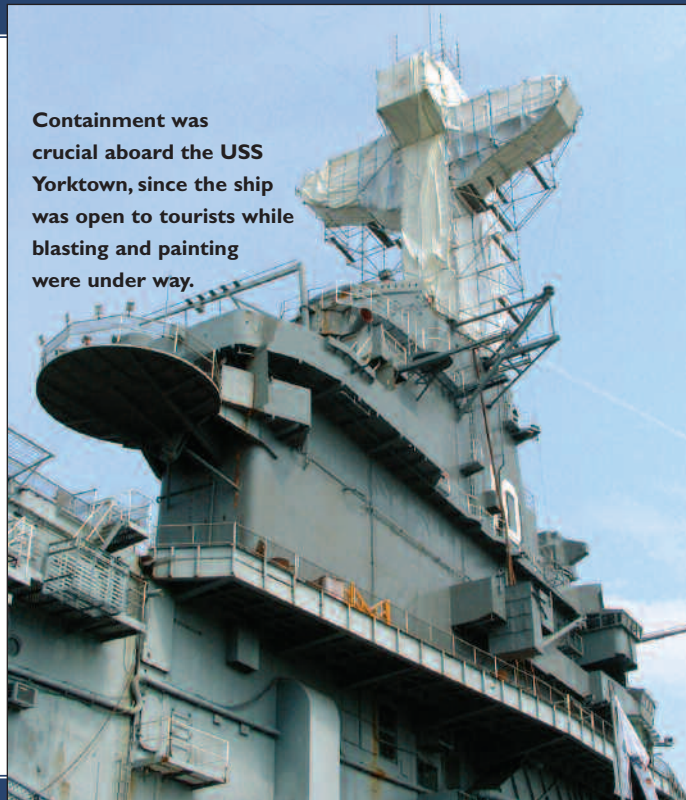
Containment was crucial aboard the USS Yorktown, since the ship was open to tourists while blasting and painting were under way.
