Dust defines brick plant job for Able Painting

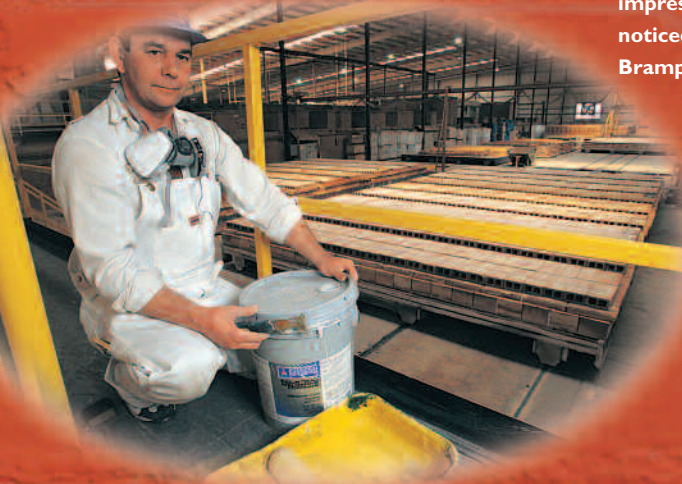
New coatings, such as the safety yellow shown here, left an impression that was noticed by officials at Brampton Brick.

The safety reds and yellows, the high gloss black on beams and the green on water tanks glistened by comparison to what had been the norm. The contrast was noted by Brampton officials — Paul remembers one summing it up by saying, “I really didn’t think it could be done.” The next step was to do the plant’s walls.

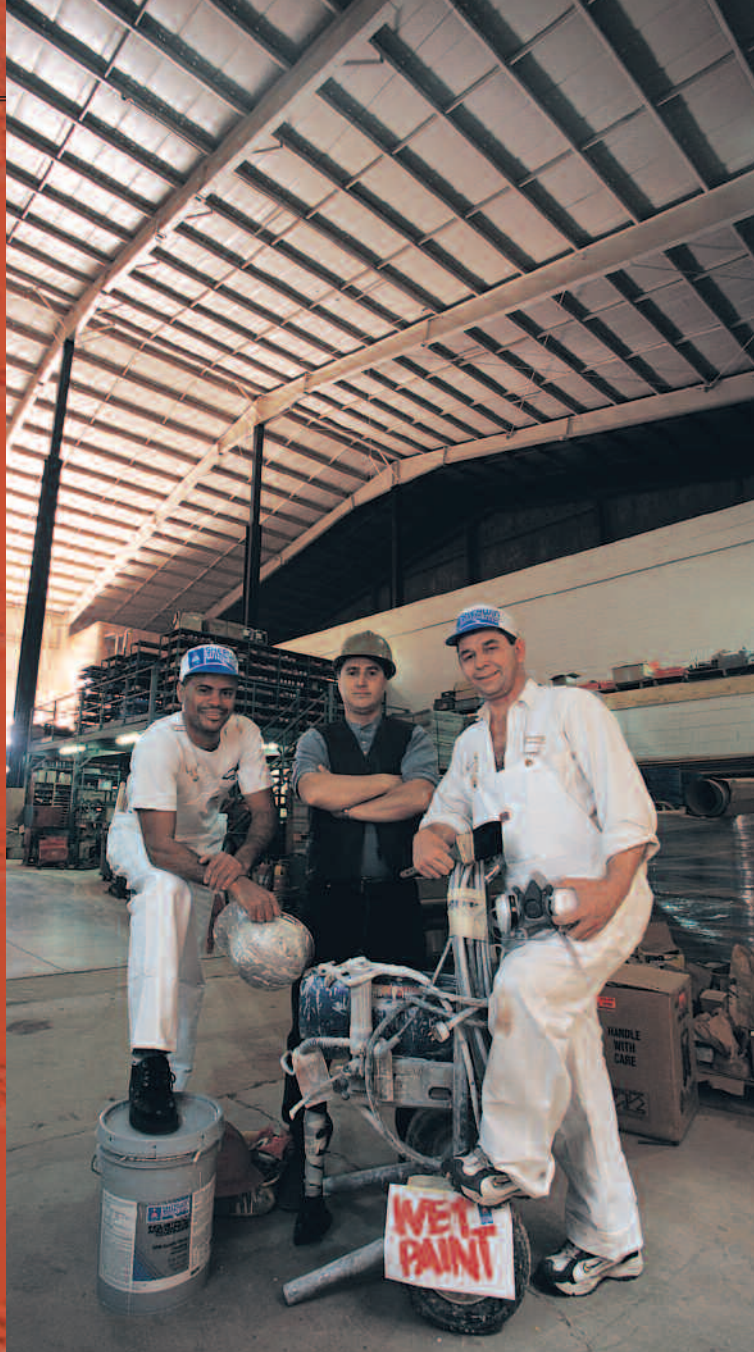
Paul Symchysn (center) and his Able Painting crew used Sherwin-Williams DTM Acrylic to successfully complete the ceiling at Brampton Brick despite temperatures that pushed 110 degrees F.

“We needed a coating that would bond with the acrylic surface and the adjacent structural steel, achieve the proper total dft of 5 mils, and adhere strongly, again all with only minimum prep work,” Symchysn points out. “Our options were very limited, We still only had the option of air blasting the ceiling panels, doing minimal tool work on the surfaces and then using airless spray technology to apply the paint.

“But for ceiling phase, we developed a swing stage, sized to fit the span between the I-beams and carry itself from the 52-foot center peak of the ceiling to the lower tops of the outside walls using just the force of gravity. The swing stage incorporates rollers that sit firmly on the I-beams of the structure and allow it to roll downward as it is guided by the painters, with primary and secondary safety lines in place.”

As with the prep work on the walls, the ceiling was carefully air blasted, hand tools were used for touch up areas, a “stripe coat” was applied to areas that needed it, and then Clay Tan DTM Acrylic was applied to achieve the 5-mil dft. The airless spray also served to disperse any clay dust that might have settled on the ceiling since the air blast.
