Launching A CLEAN IMAGE

Bath Iron Works puts a new face on an old industry

ASSEMBLY BUILDING FACELIFT

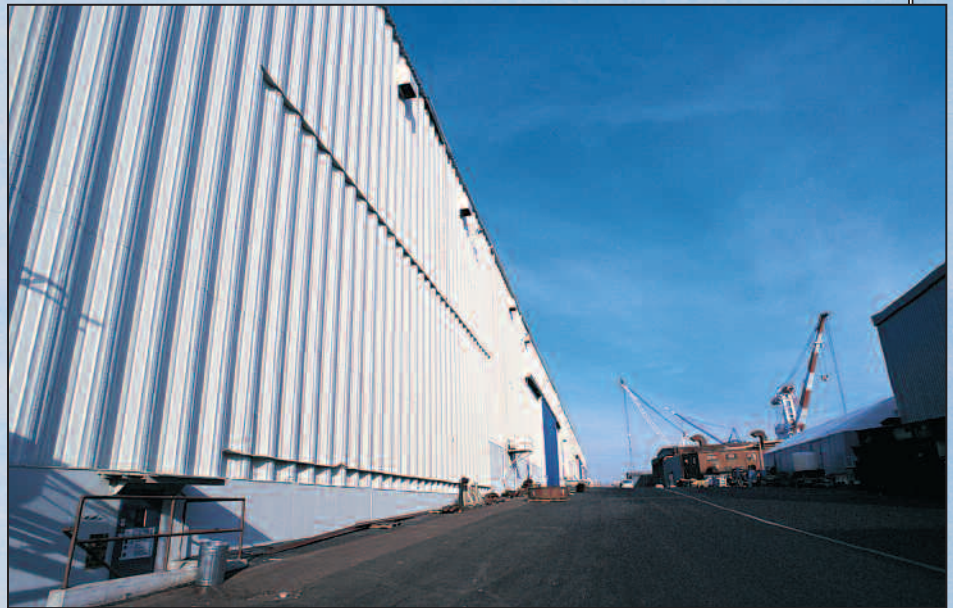
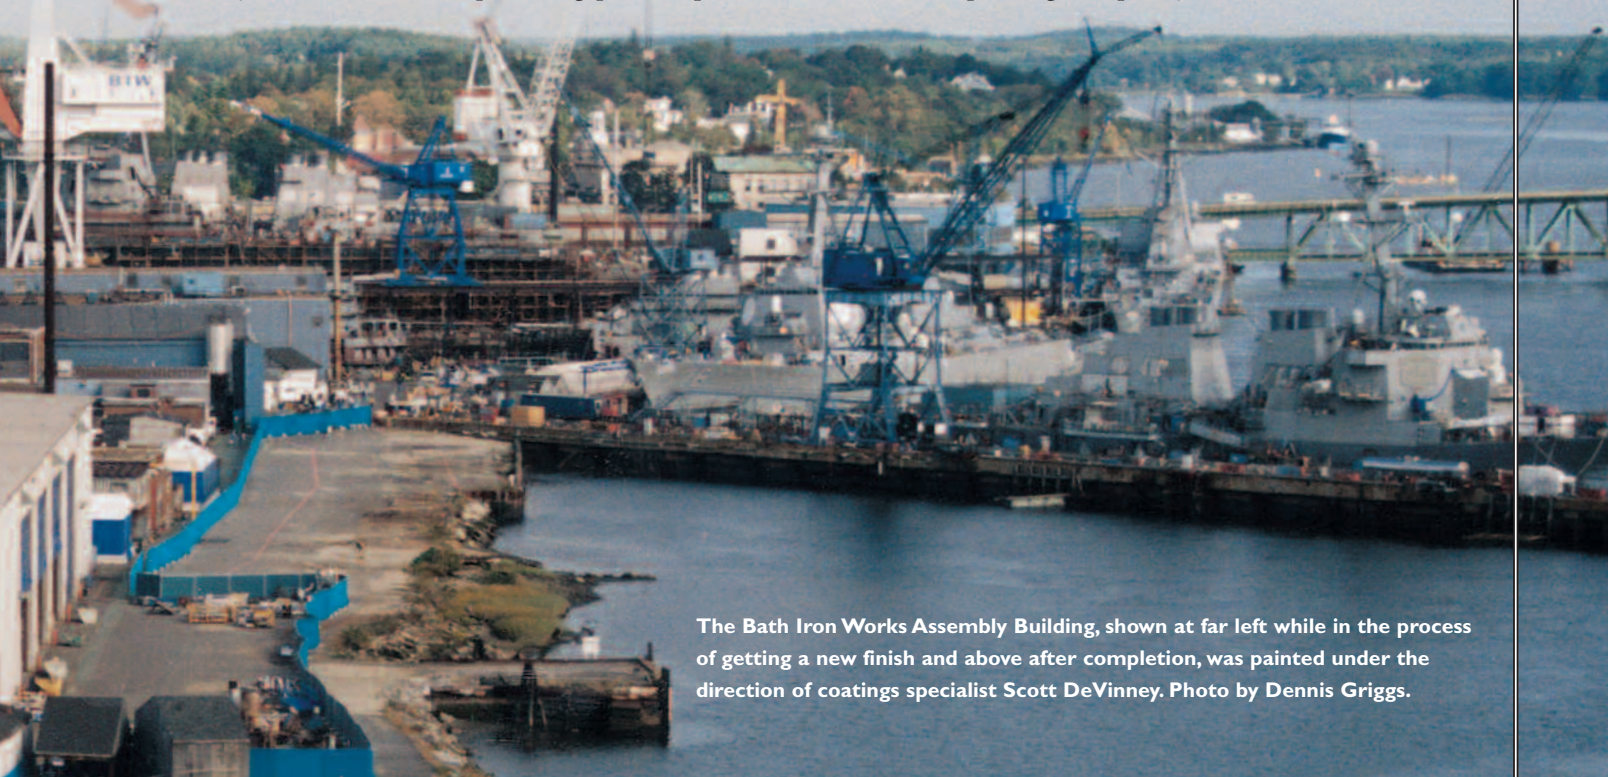
The task of coating it, however, was a tricky one from the start. The building, which bore its original paint from some two decades earlier, had accrued some severe rust staining, especially near exterior ventilation ducts where weld smoke and iron particles, according to DeVinney, had been exhausted out of the building and concentrated over the years.

The Bath Iron Works Assembly Building, shown at far left while in the process of getting a new finish and above after completion, was painted under the direction of coatings specialist Scott DeVinney. Photo by Dennis Griggs.

At this point, Sherwin-Williams corrosion specification engineer Bob Murphy offered several possible solutions, and he and DeVinney settled on an approach involving the use of a surface treatment solution to address the rust staining, followed by the application of the coating system. The call proved to be the right one.

Using airless spray equipment, painters first applied DTM Bonding Primer, selected for its outstanding adhesion properties, according to DeVinney. Even though the crews were using the product for the first time, they found application characteristics to exceed their expectations.

A single coat of DTM Acrylic made up the finish, leaving a total dry film thickness of 5-8 mils and a building that no longer bears the scars of years in a harsh industrial setting.

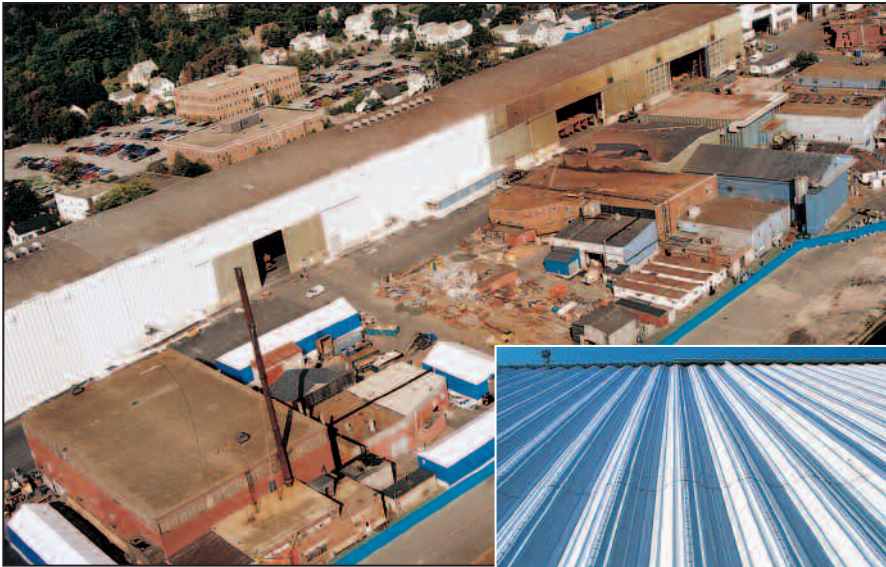
The corrugated steel exterior of the Assembly Building took on a new look after completion of the coating project. Below, BIW coatings specialist Scott DeVinney.
