SQUEEZING time

Coating Welch's
tank rooms
required precise
timing, expertise

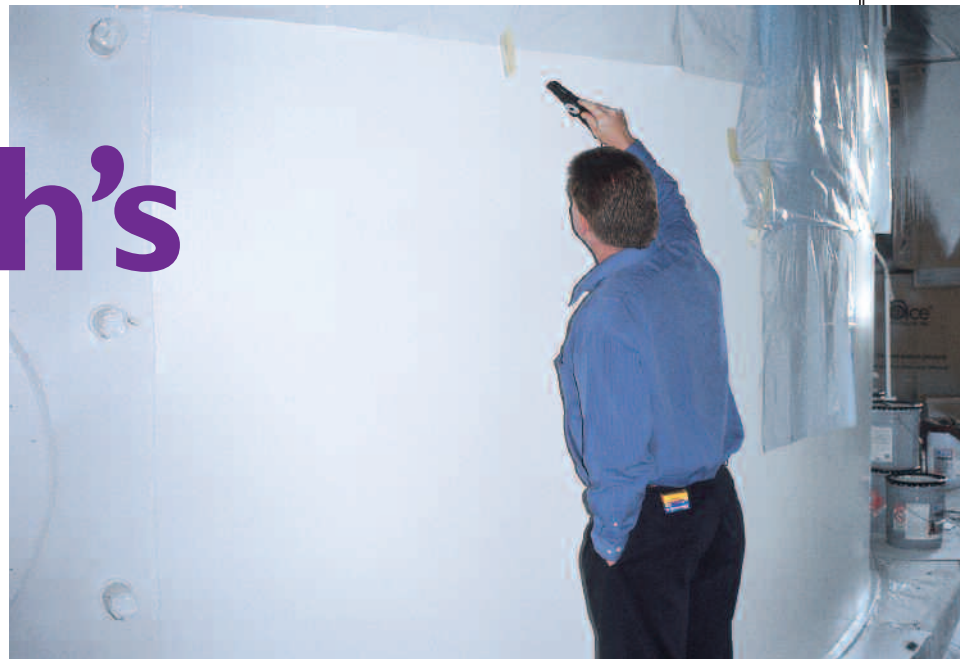
Sherwin-Williams Industrial and Marine representative Jim Adcock measures film thickness at Welch's Tank Room 5.

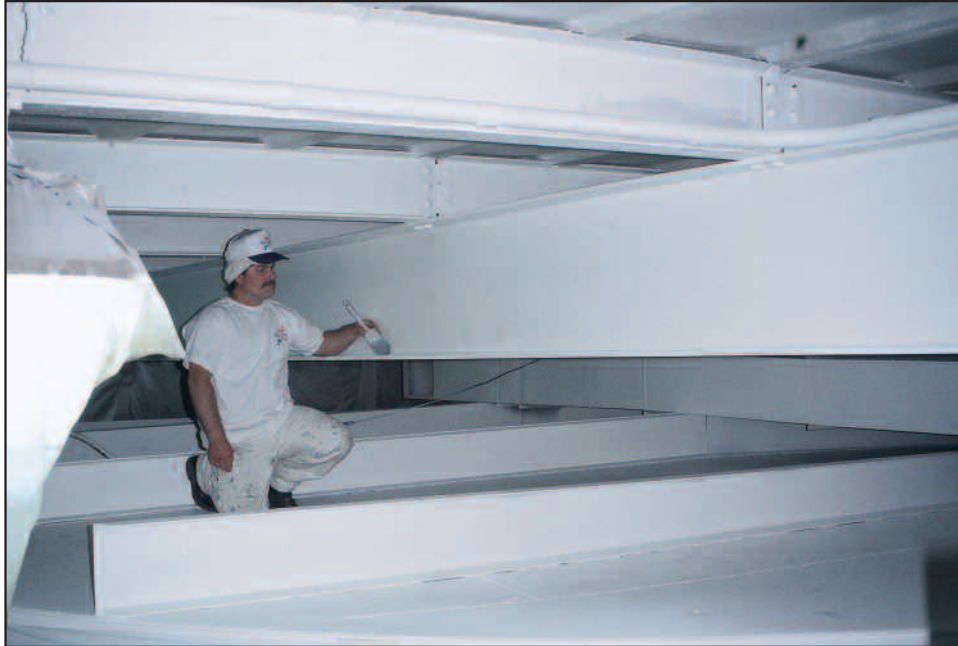
A three-coat Sherwin-Williams system was applied to the tanks and other steel in Welch's Tank Room 5.

Once the blasting was finished, the site clean up completed and the room thoroughly aired, the three-coat system was applied to the tanks and other steel. The primer coat was Sherwin-Williams Macropoxy 646 at 3.0 to 5.0 mils dft. An intermediate coat of Macropoxy 646 was applied, between 24 and 72 hours later, at 4.0 to 6.0 mils dft. And some 72 to 96 hours later, the finish coat of Sherwin-Williams Armor-Tile High Solids Epoxy was applied at 2.5 to 4.0 mils dft. All coats were applied using airless spray technology and equipment, with some brush-and-roll touchup. Paint crews also hand cleaned and caulked spot welds on the beams that formed a superstructure above the tanks themselves.
