One Better

AT A GLANCE

Lakehead Painting fine-tunes unique gas sphere recoat procedure

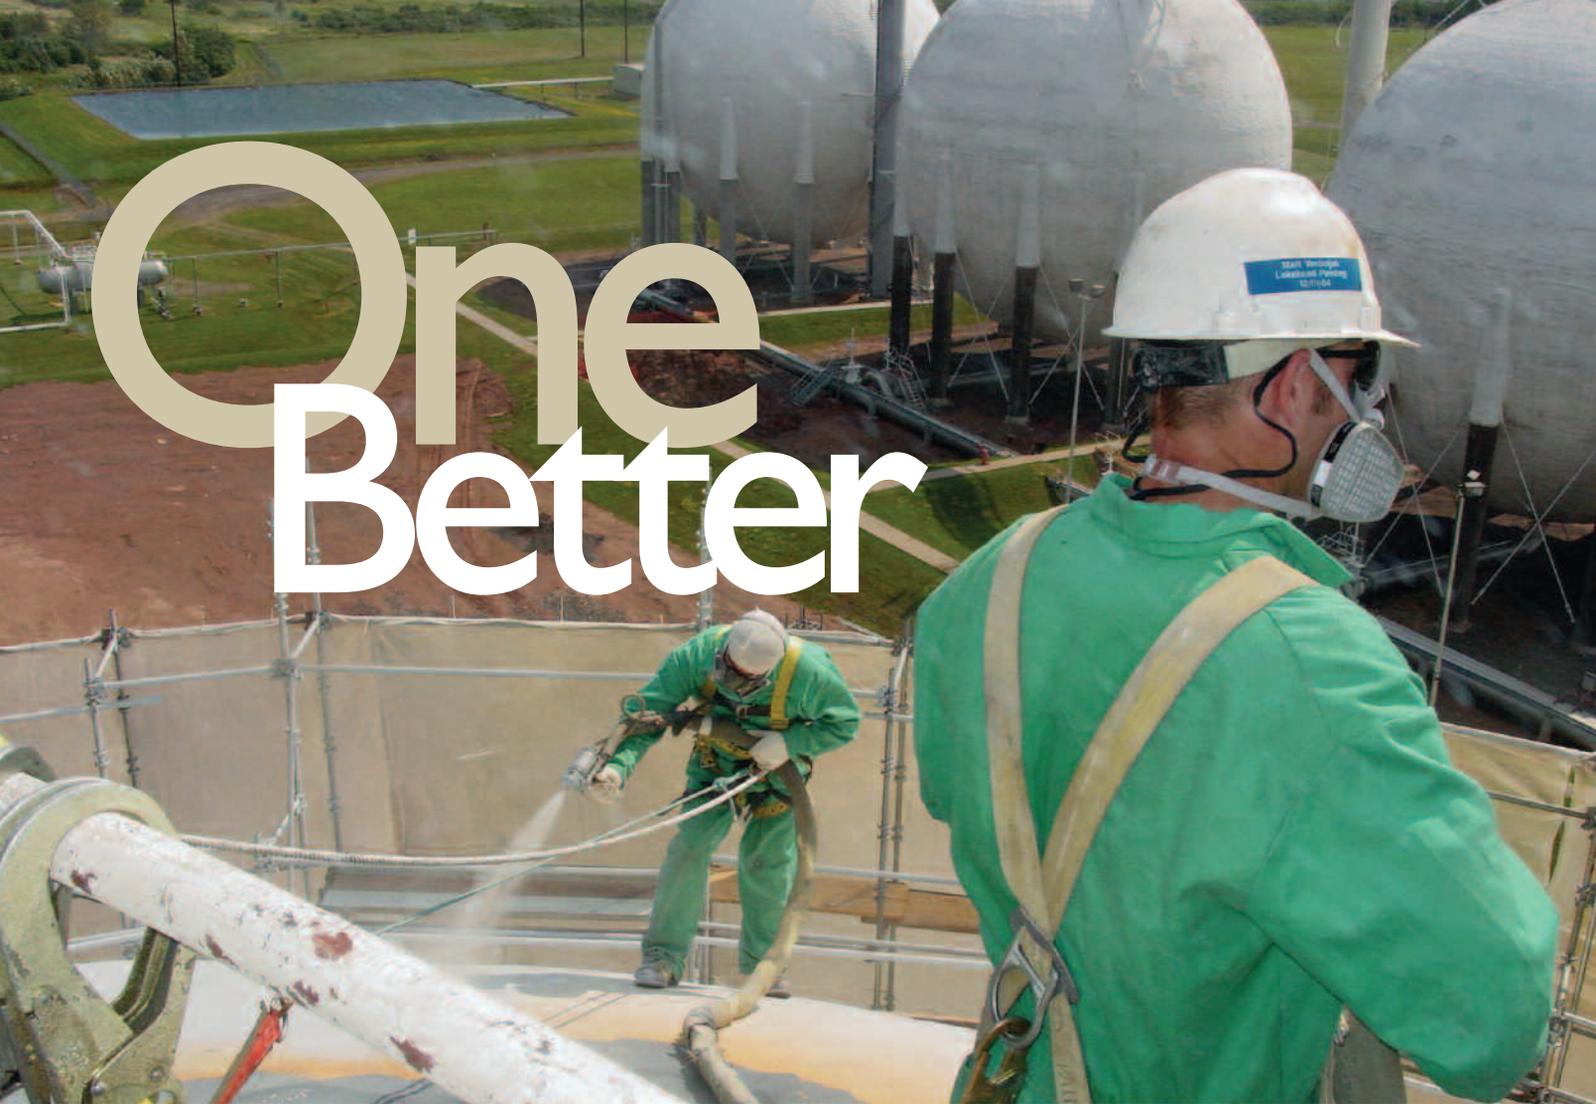
- Gas sphere “shrink-wrapped” in polyurea system in part to preserve existing insulation.
- This tank, completed in 2005, was second to occur on the grounds. First was refinished with a similar system in 2004.

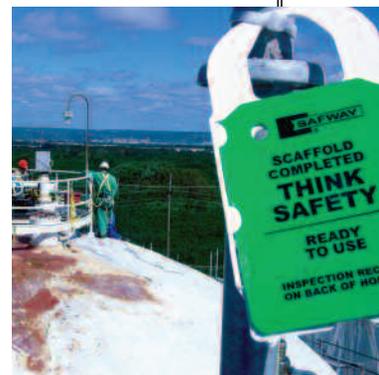
A team led by Lakehead Painting personnel managed logistics in the application of an innovative Sherwin-Williams polyurea system (left) to one of six gas spheres (below) owned by BP Canada in Superior, Wis., last summer. As is typical of BP projects, safety was made top of mind for all subcontractors present (above).
