WATER, WATER *Anywh*

Tank repaint draws attention in water-sensitive Los

- Maintenance repaint of a 55-year-old potable water storage tank in Los Alamos, N.M.
- Painting performed by Rickert Industrial Coatings
- Sherwin-Williams epoxy system that included a moisture-cure primer

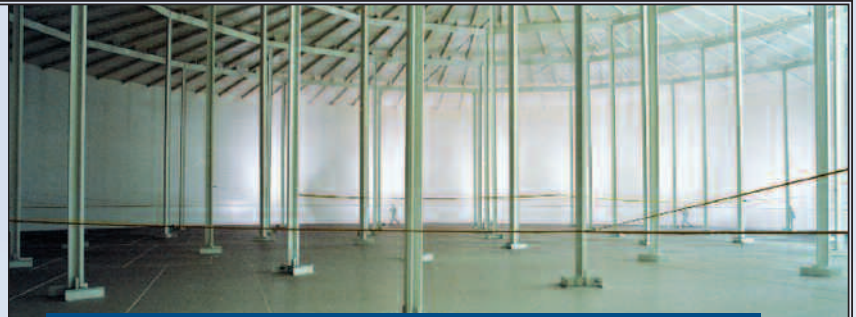
The tank on the west side of Los Alamos blends into its environment.

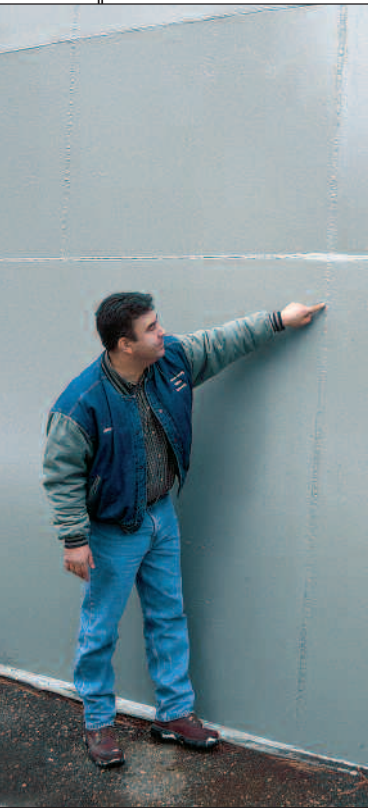
Getting an up-close look at a tank seam is James Alarid, an engineer with the Los Alamos County Department of Public Utilities. The seam is the result of an opening painters had cut into the tank wall to move equipment and personnel inside (right).
