WATER WORK

MCU SYSTEM, CONTRACTOR TACKLE CHALLENGING FILTRATION PLANT PROJECT

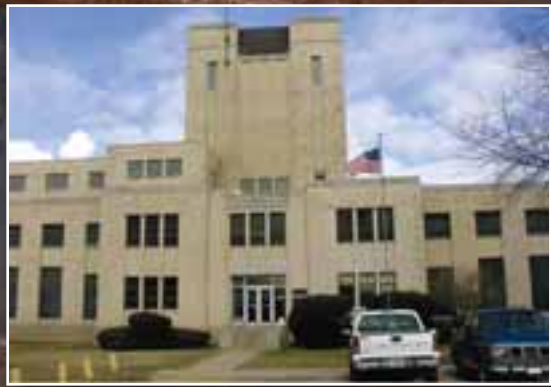
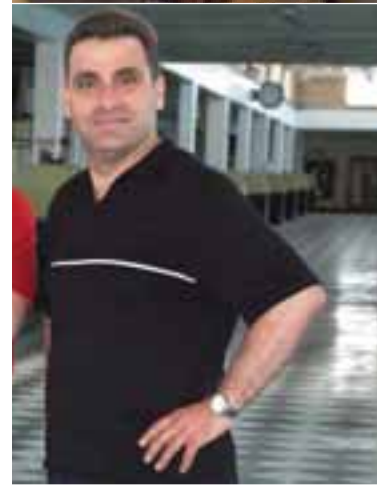
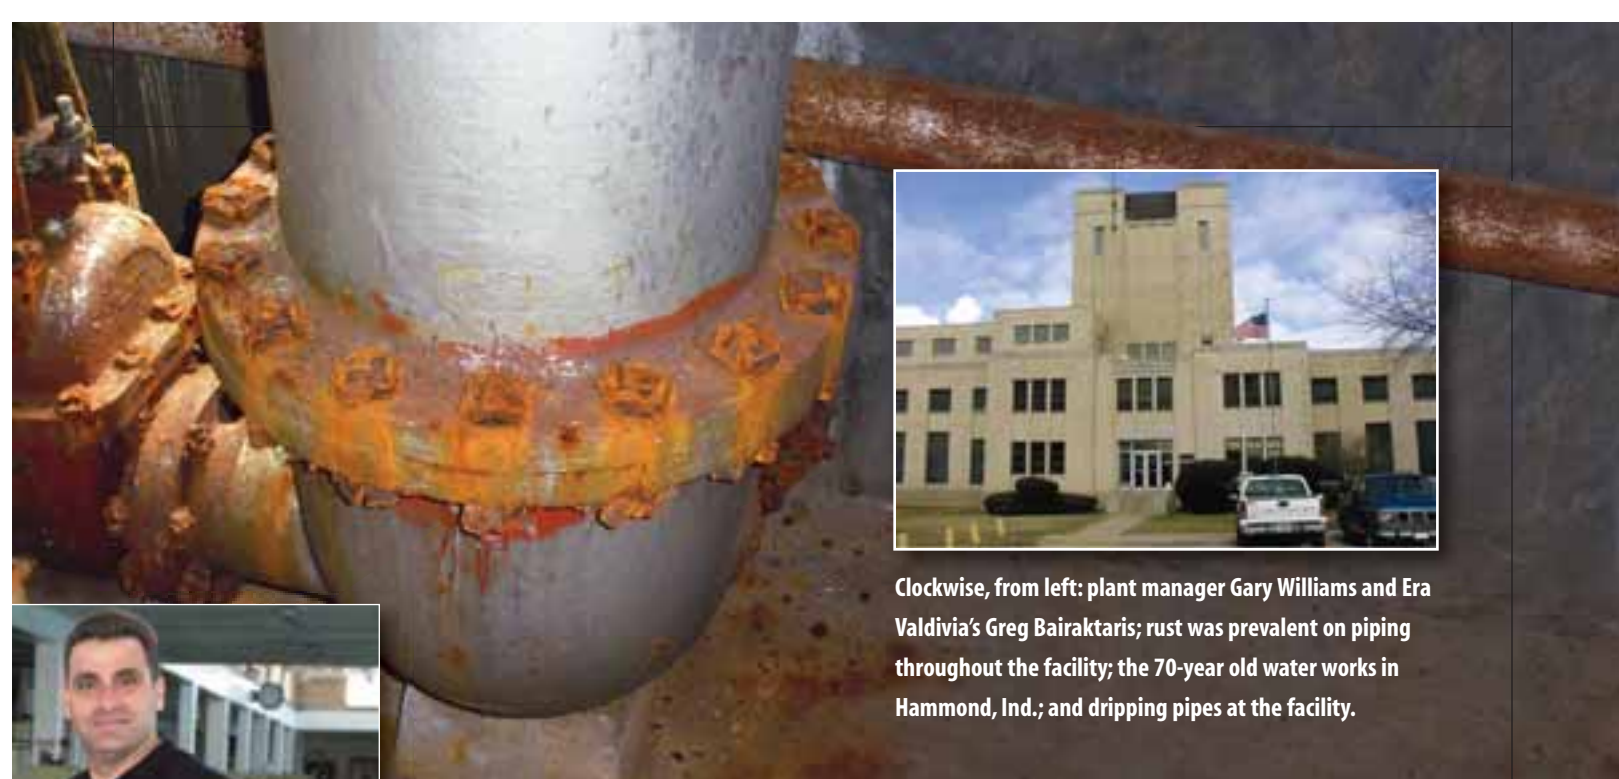
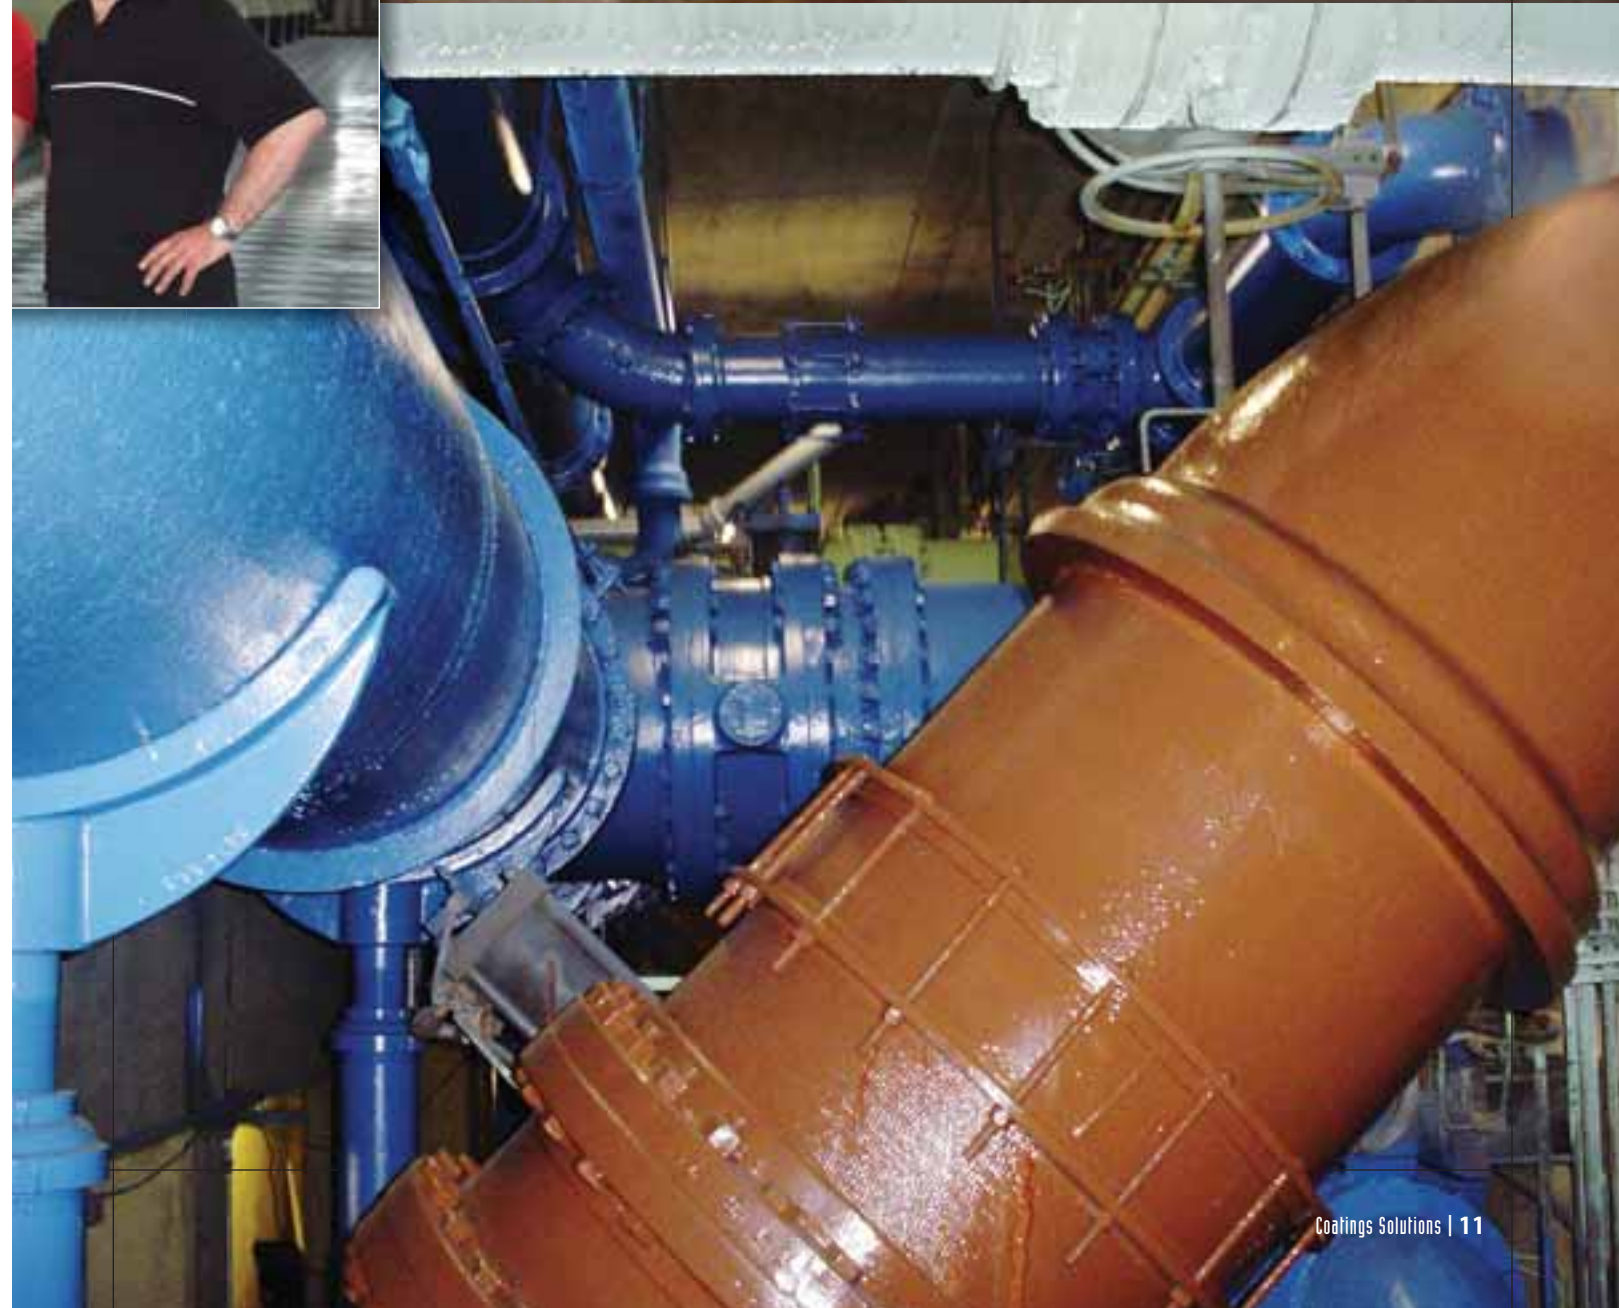
Clockwise, from left: plant manager Gary Williams and Era Valdivia's Greg Bairaktaris; rust was prevalent on piping throughout the facility; the 70-year old water works in Hammond, Ind.; and dripping pipes at the facility.

Due to the significant moisture found on the pipes, painters had to limit their work to a single room at a time and follow blasting as quickly as a day later with priming.

"It was hard to get that surface clean enough," says Bairaktaris. "You couldn't get the cast iron to near-white, but we got it as close as we could and painted quickly. If we didn't have the dehumidification we were going to have flash rusting, but once the pipes had a coat of paint on them, we could shut the dehumidification off."
