Surprises taken in stride at Kane Inc. on tank repaint

The successful maintenance repaint of a 5 million-gallon water tank in Anchorage, Alaska, last summer figured to be enough of a challenge without the following factors thrown into the mix:

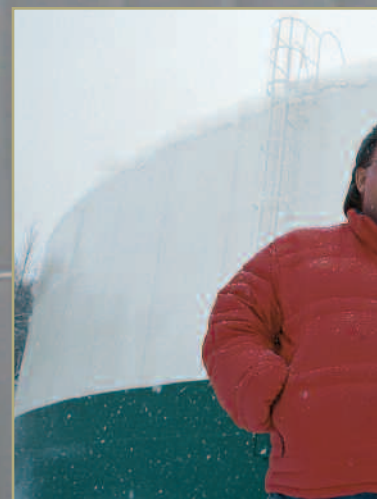
A painter applies Fast Clad Zinc HS to cleaned and blasted steel on the surface of a 5-million-gallon water tank in Anchorage, Alaska. Above, AWWU engineer Sid Taylor and the finished tank brave a snow shower.

The three-coat Sherwin-Williams exterior system called for surface prep to SSPC SP-10. Following were a prime coat of Fast Clad Zinc HS at 3.0 - 5.0 mils dft, an intermediate coat of MacroPoxy 646-NSF Fast Cure Epoxy and a topcoat of SherThane 2K at 3.0 - 5.0 mils dft. After surface prep to SSPC SP-10, the interior specification called for three coats of epoxy, and Kane selected MacroPoxy 646-NSF, each coat at 3.0 - 5.0 mils dft.

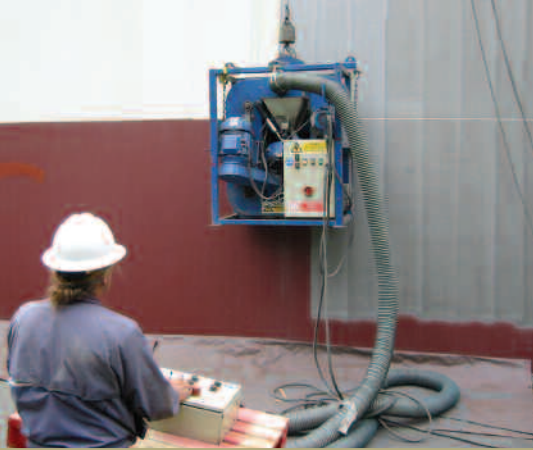
Contractor Kane Inc. leased the services of a BlasTrac unit to expedite surface preparation on the project.

Starting on-site in the first week of June, 2004, Kane Inc. expedited surface preparation of the exterior by subcontracting the use of a BlasTrac unit, which kept other workers free to follow the unit spraying the primer. Surface preparation of the interior, however, led to a surprise discovery. After
